MEMORANDUM

TO: Amy Beatty, Community Services Director
FROM: Sally Thigpen, Assistant Director
DATE: July 14, 2023
SUBJECT: Tree Removal on Market St- Council Information

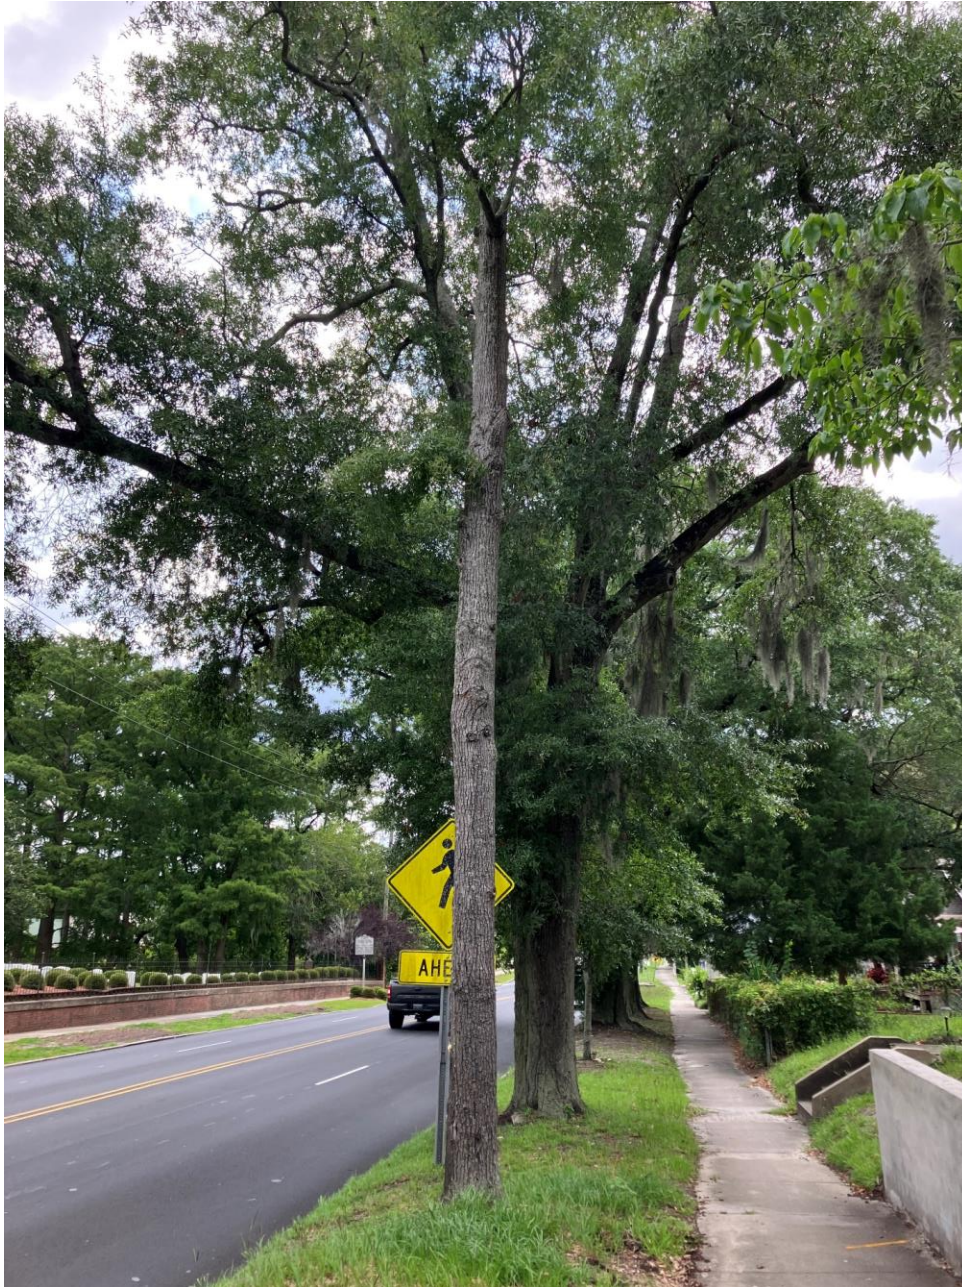
Figure 1 TREE 1

7. TREE ID #3
 - a. 1820 Market St.
 - b. 35” DBH Laurel Oak
 - c. Significant decay in trunk and crown.
8. TREE ID #1
 - a. 2010 Market St.
 - b. 13.5” DBH Laurel Oak

- c. Snag with borers, POLYPORE FUNGAL CONK ON LOWER STEM
9. TREE ID #9
 - a. 1617 Market St. (Funeral Home) (INSPECTION AT HEIGHT REQUIRED)
 - b. Laurel Oak

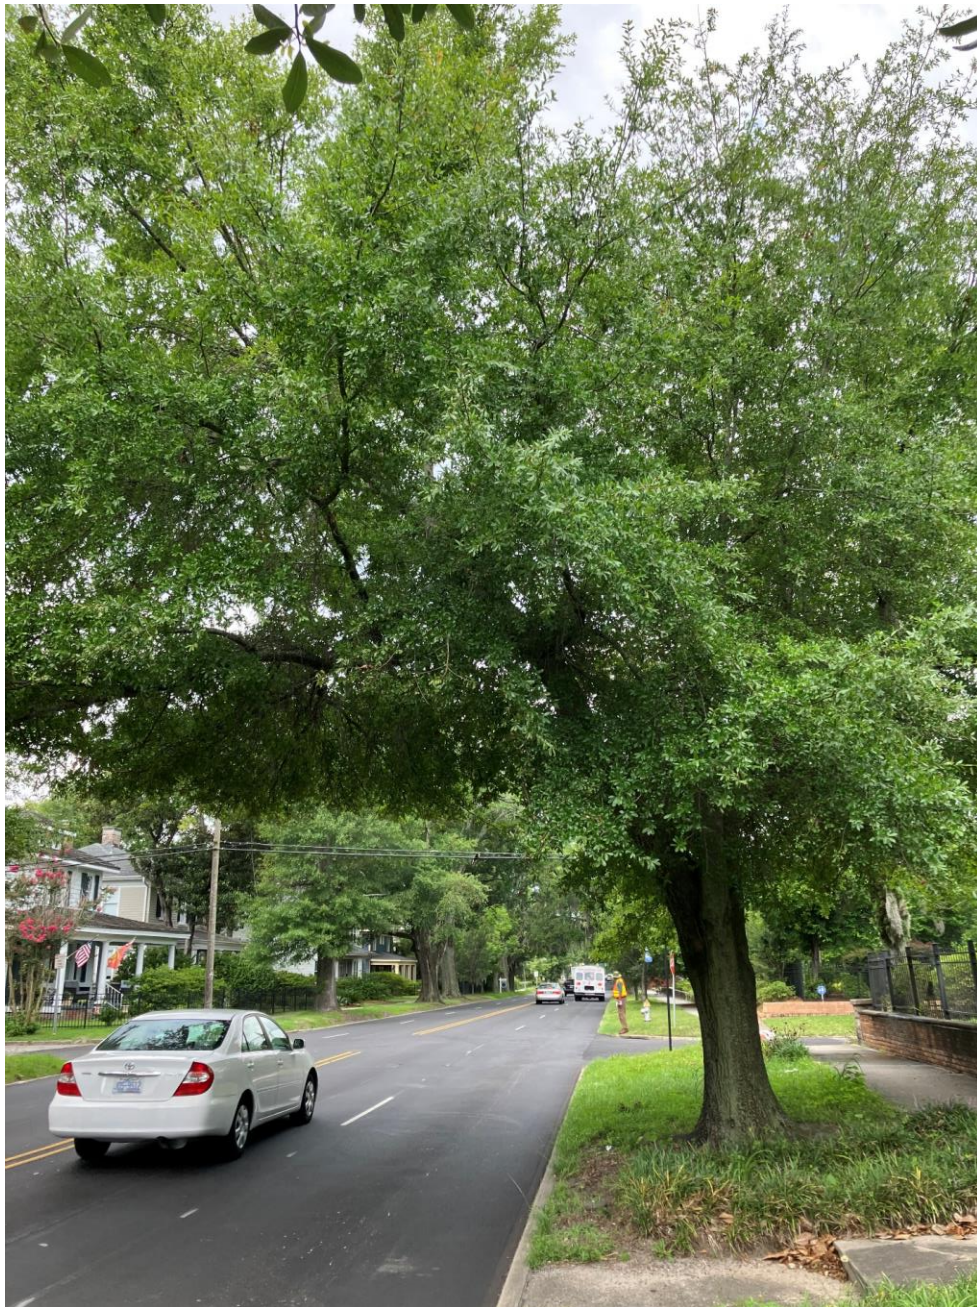
Figure 2 TREE 2

1. TREE ID #2
 - a. 1901 Market St.
 - b. 21” DBH Laurel Oak
 - c. Decay in crown over road. Splitting seam/included bark. History of failures evident.
2. TREE ID #6

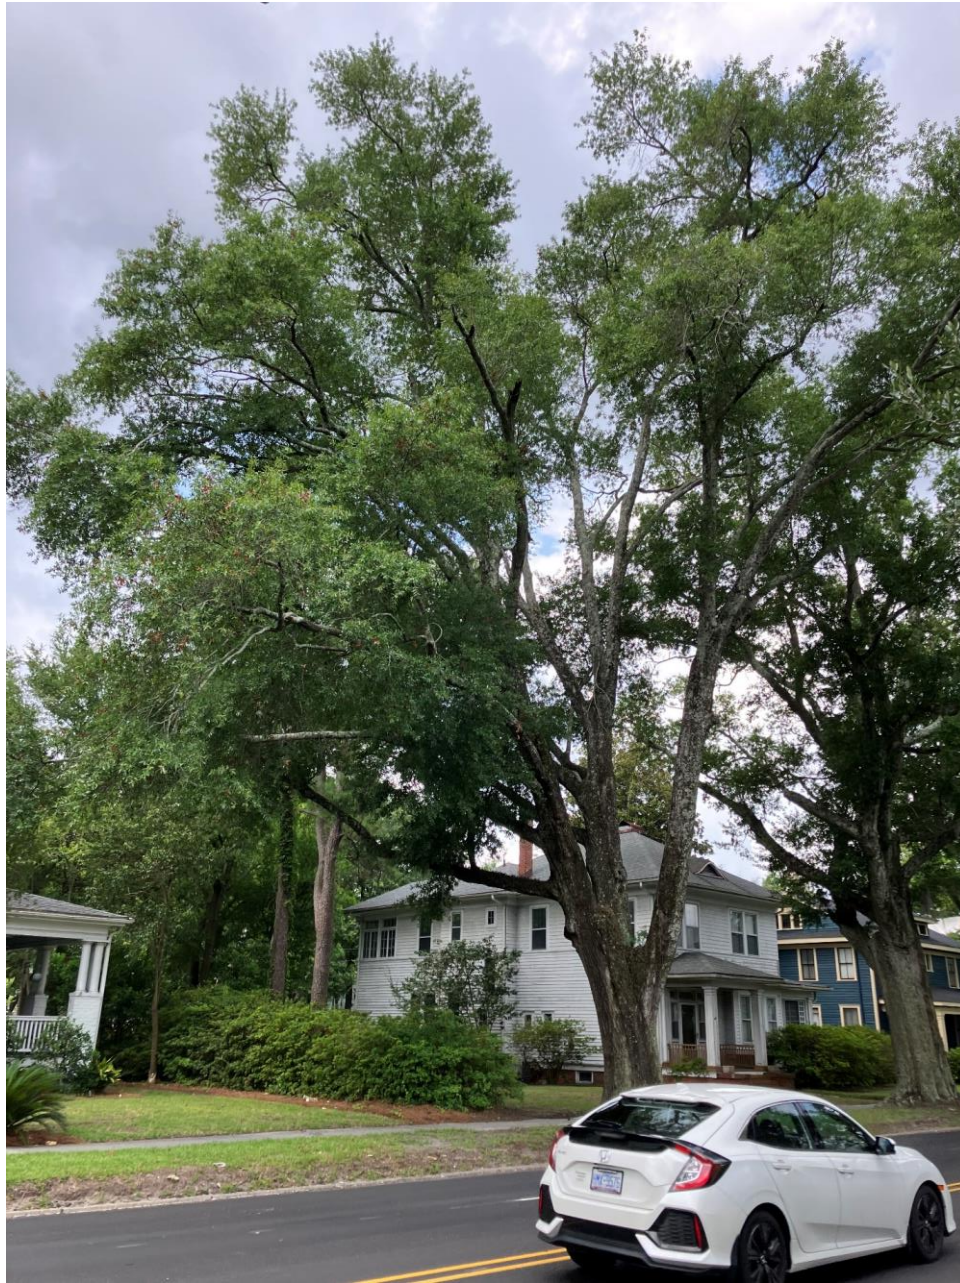
Figure 4 TREE 4

- c. Significant signs of basal decay. Ganoderma conks present.
6. TREE ID #4
 - a. 1812 Market St. (INSPECTION AT HEIGHT REQUIRED)
 - b. Aerial inspection required for large codominant stems with crack.

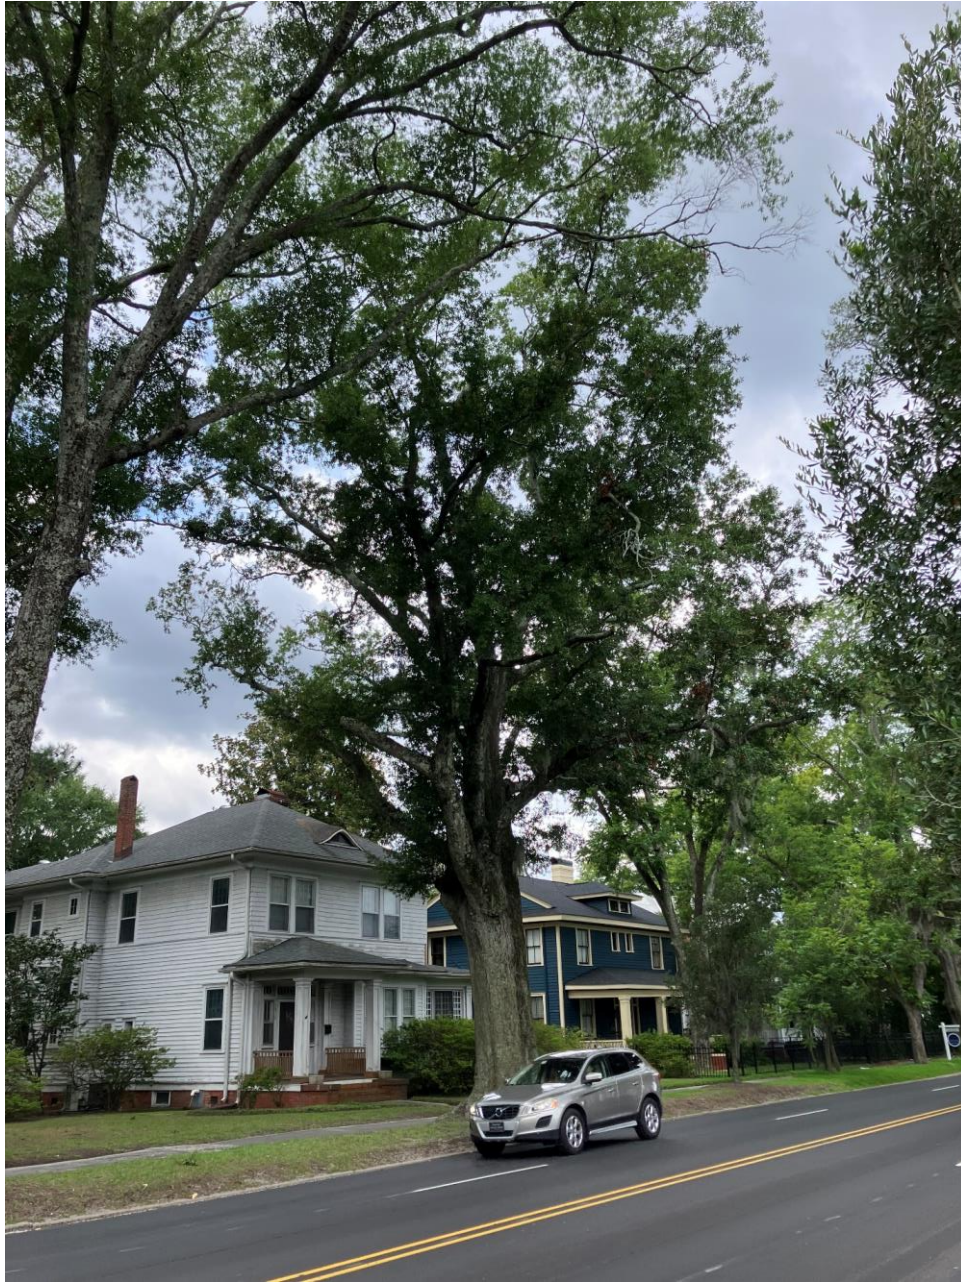
Figure 5 TREE 5

4. TREE ID #8
 - a. 1704 Market St.
 - b. 26” DBH Laurel Oak
 - c. Dieback in crown. Extensive water sprouts.
5. TREE ID #5
 - a. 1810 Market St.
 - b. 55.5” DBH Laurel Oak

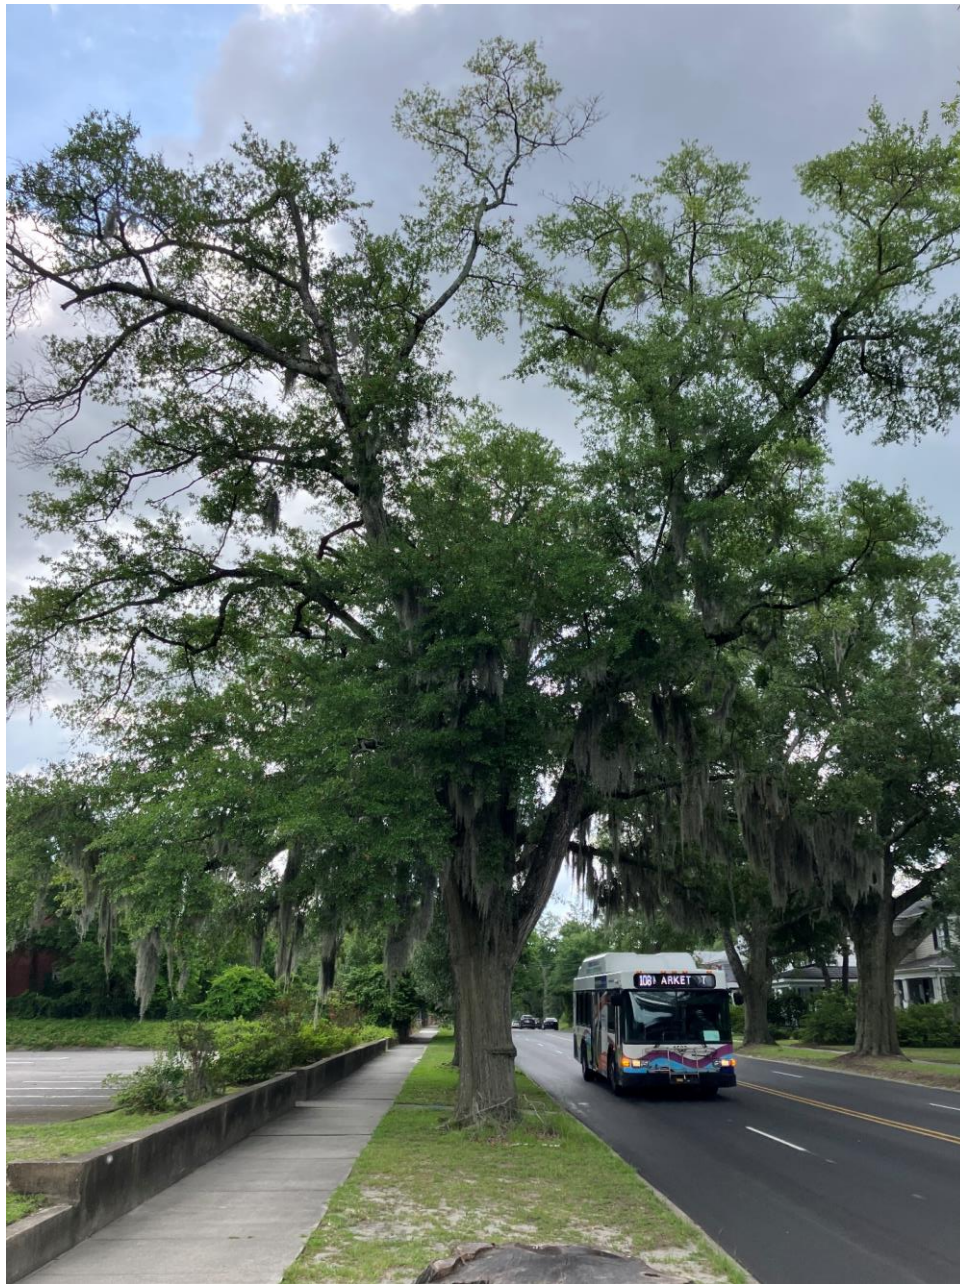
Figure 6 TREE 6

- a. 1801 Market St. (Temple Baptist Church)
 - b. 33.5” DBH Laurel Oak
 - c. Decay in crown over road. Cracked limb over sidewalk and parking lot. History of failures evident. Basal decay.

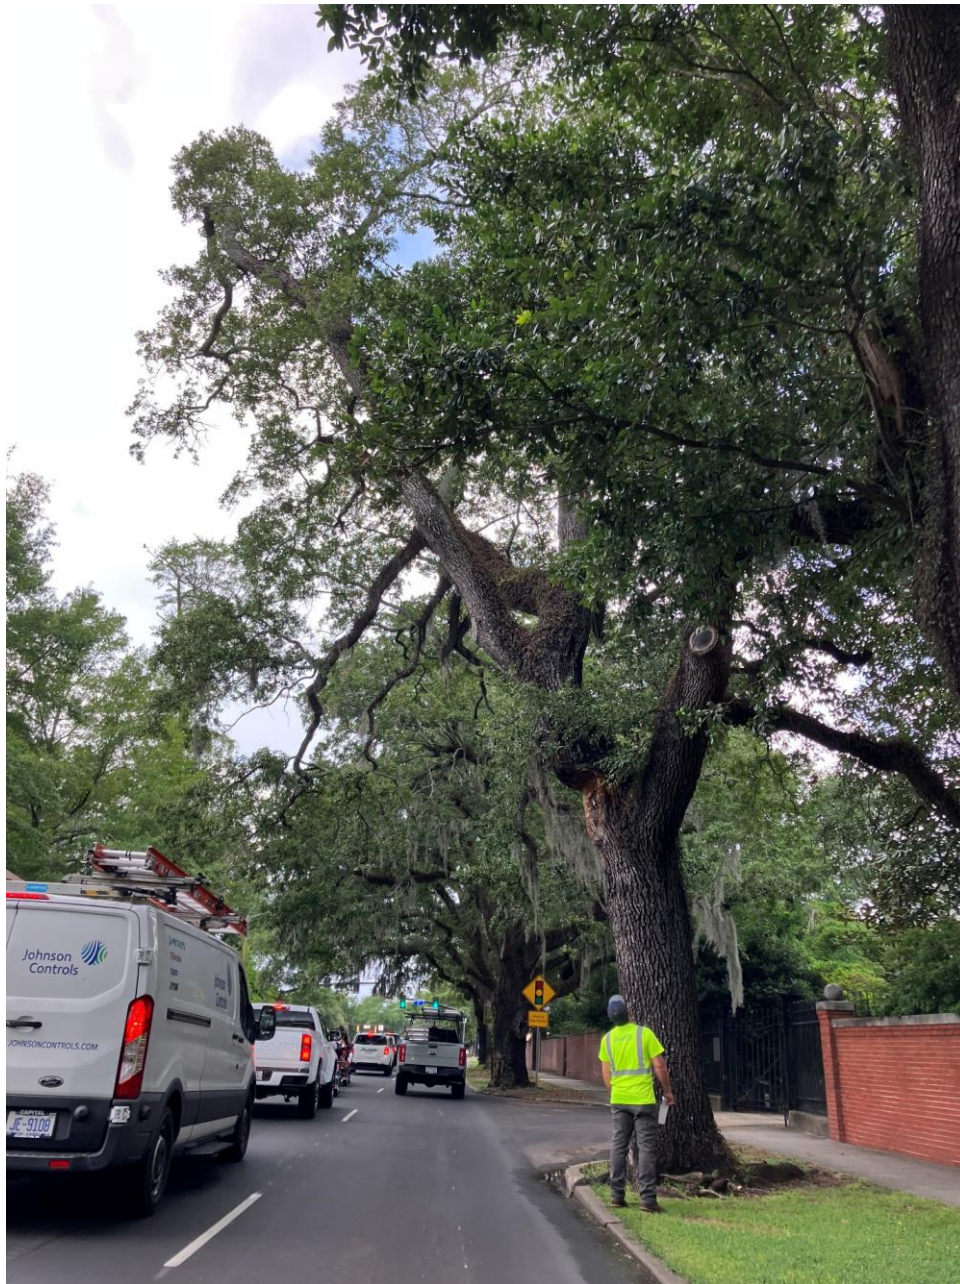
Figure 7 TREE 7

3. TREE ID #7
 - a. 1713 Market St.
 - b. 33.75” DBH Live Oak
 - c. A significant structural defect caused by repeated truck damage. Possible crack above defect.

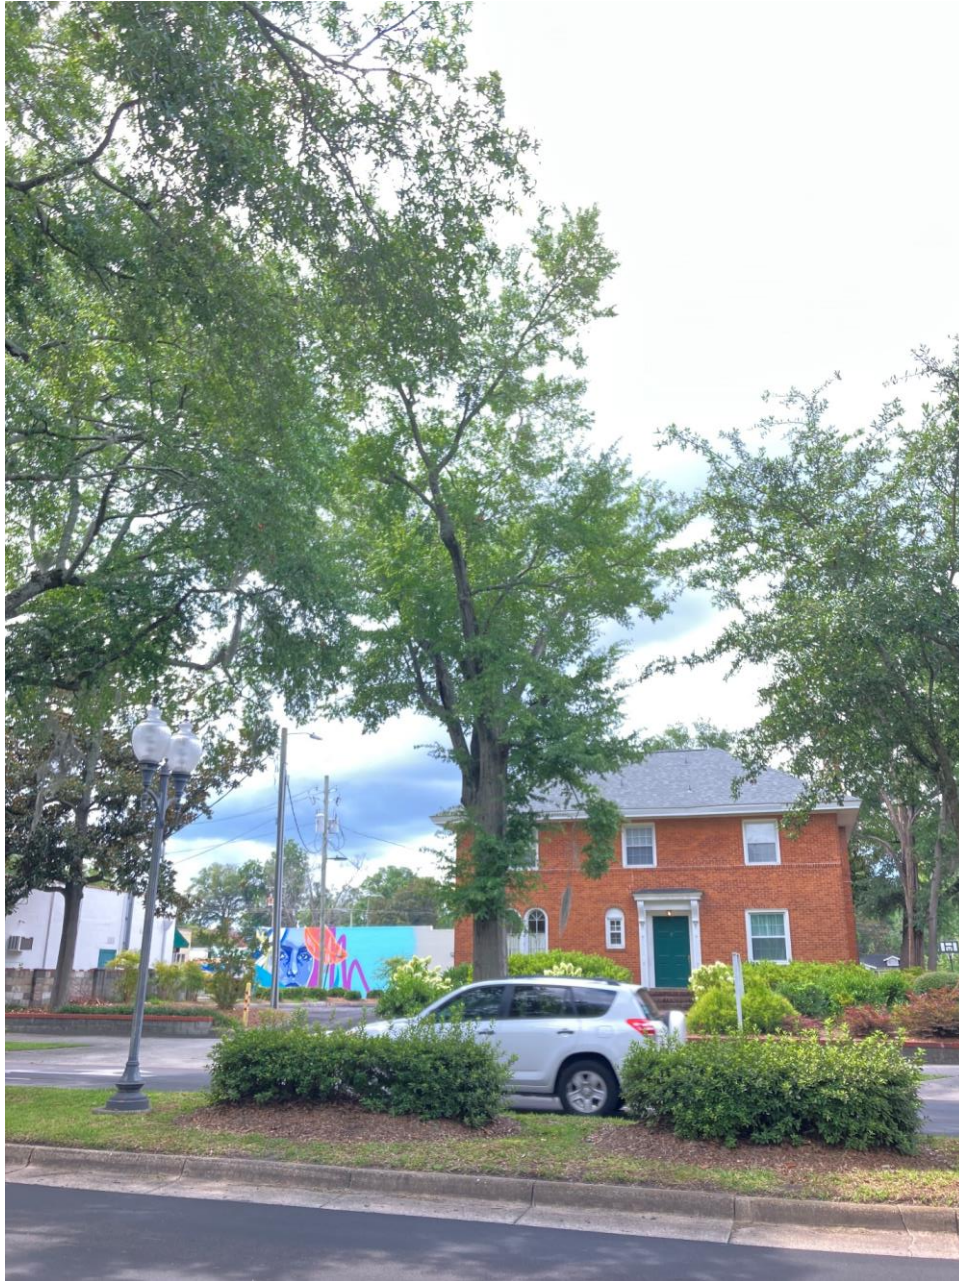
Figure 11 TREE 11

- c. Significant decay in crown.
19. TREE ID #11
- a. 1516 Market St.
 - b. 29" DBH Laurel Oak
 - c. Significant decay in crown. History of limb failures.

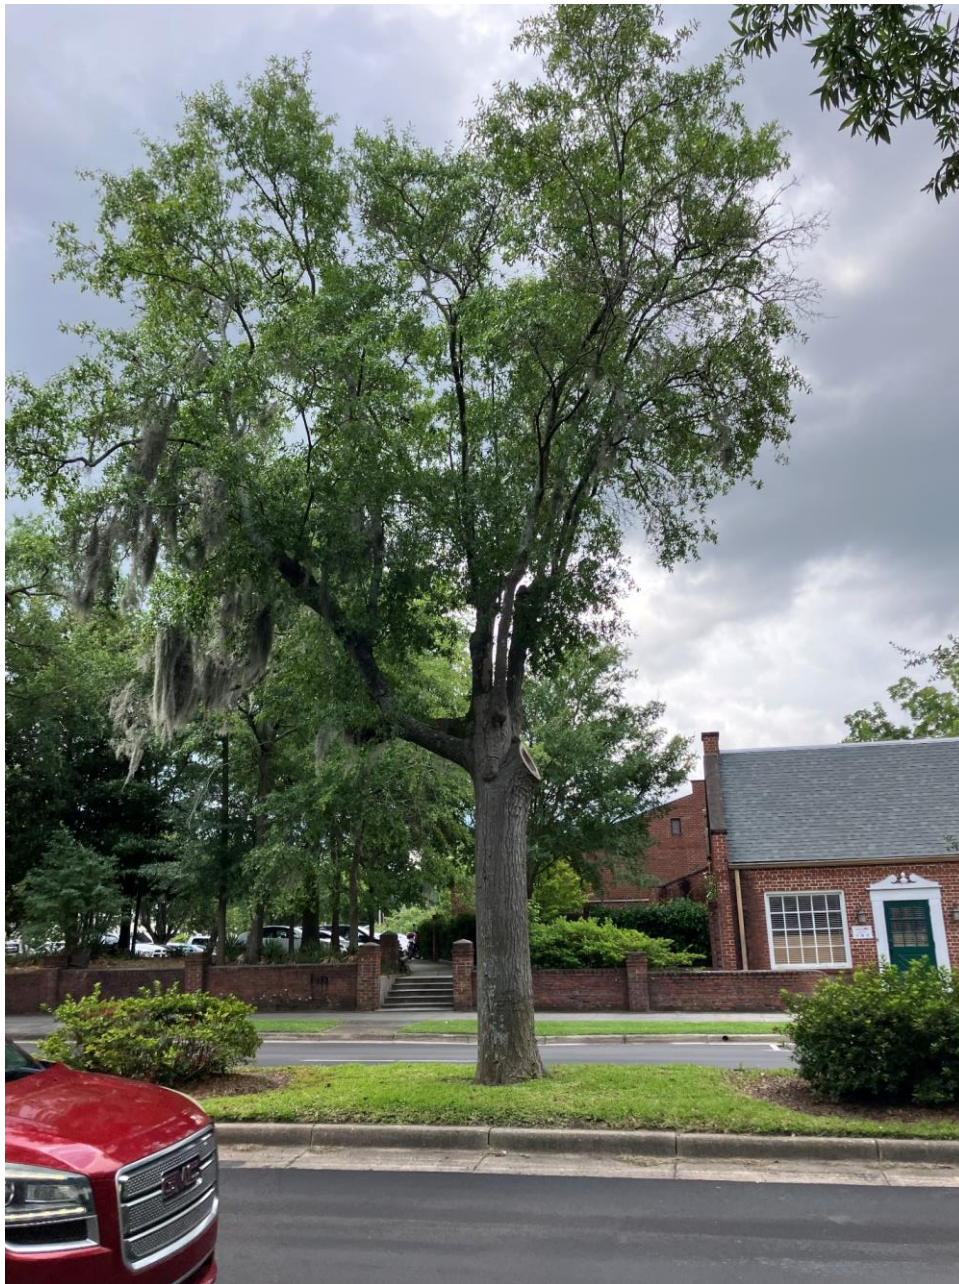
Figure 13 TREE 13

17. TREE ID #19
- a. 1209 Market St.
 - b. 26" DBH Laurel Oak
 - c. Split in trunk. Deadwood in crown.
18. TREE ID #13
- a. 1502 Market St.
 - b. 22" DBH Laurel Oak (In median)

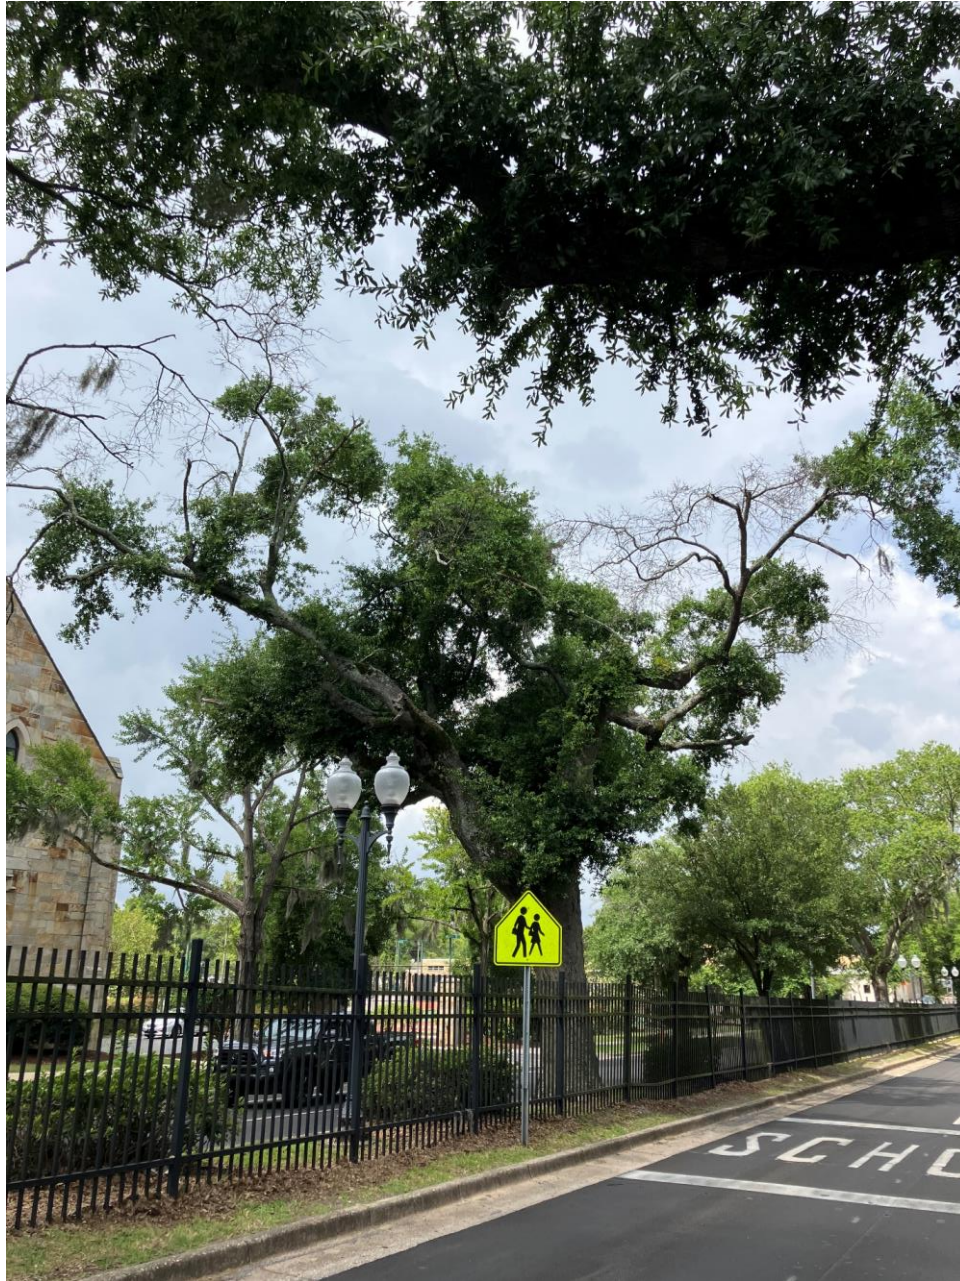
Figure 15 TREE 15

13. TREE ID #15
- a. 1417 Market St.
 - b. 1 Laurel Oak in median
 - c. Decay in crown. History of large limb failures.
14. TREE ID #16
- a. NEW 7/13/23
 - b. 1419 Market St.

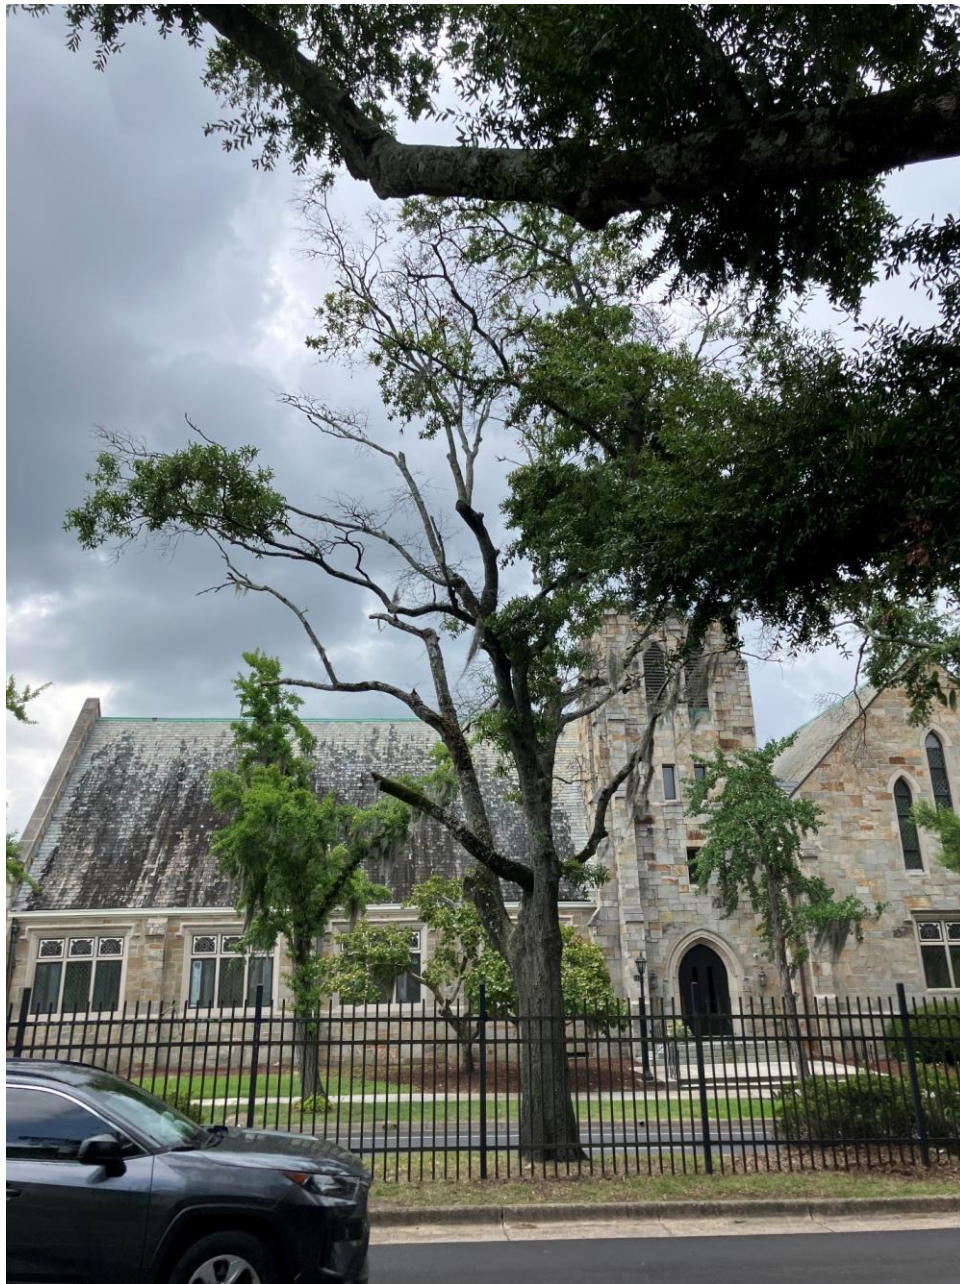
Figure 16 TREE 16

- c. Unmeasured DBH Laurel Oak in median
 - d. Decay in crown.
15. TREE ID #18
- a. 1403 Market St. (Trinity United Methodist Church)
 - b. 36" DBH Laurel Oak

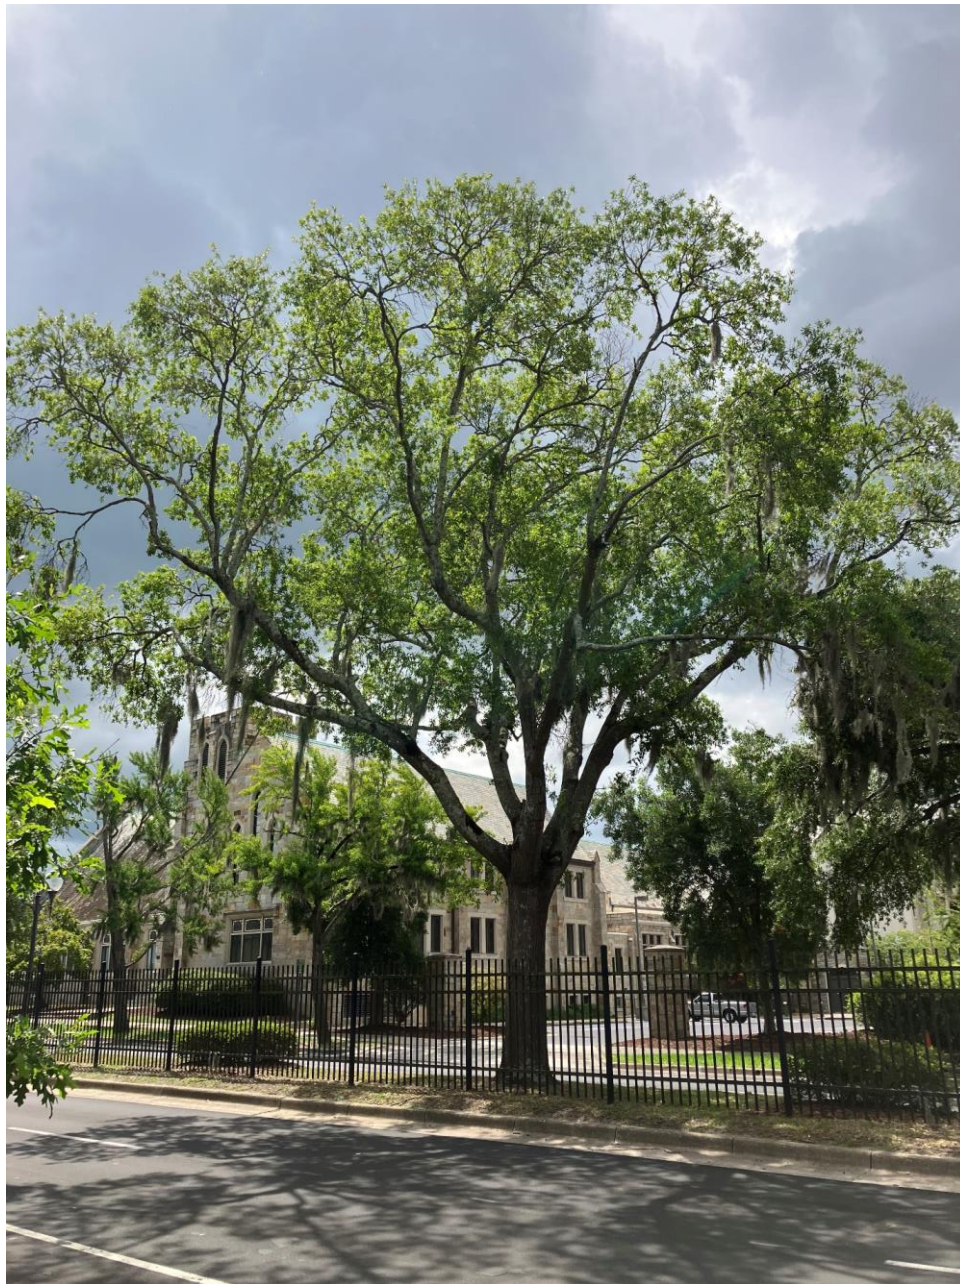
Figure 17 TREE 17

16. TREE ID #17
- a. 1403 Market St. (Trinity United Methodist Church)
 - b. 20" DBH Laurel Oak in median
 - c. Significant decay in central crown and trunk.
