Public Meeting #1

Brookshire Lane/Beasley Road Stormwater Improvements

May 30, 2013

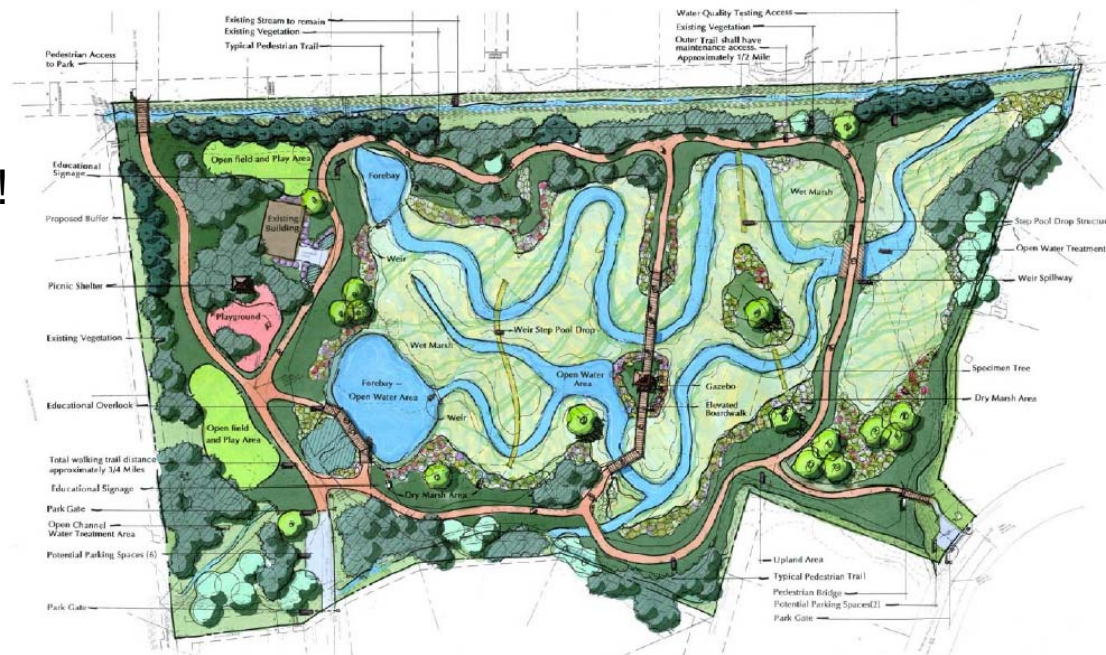
The J.E.L. Wade Wetland treats stormwater runoff from a 589 acre watershed

Reduces the volume of stormwater, fecal coliform, suspended solids and nutrients

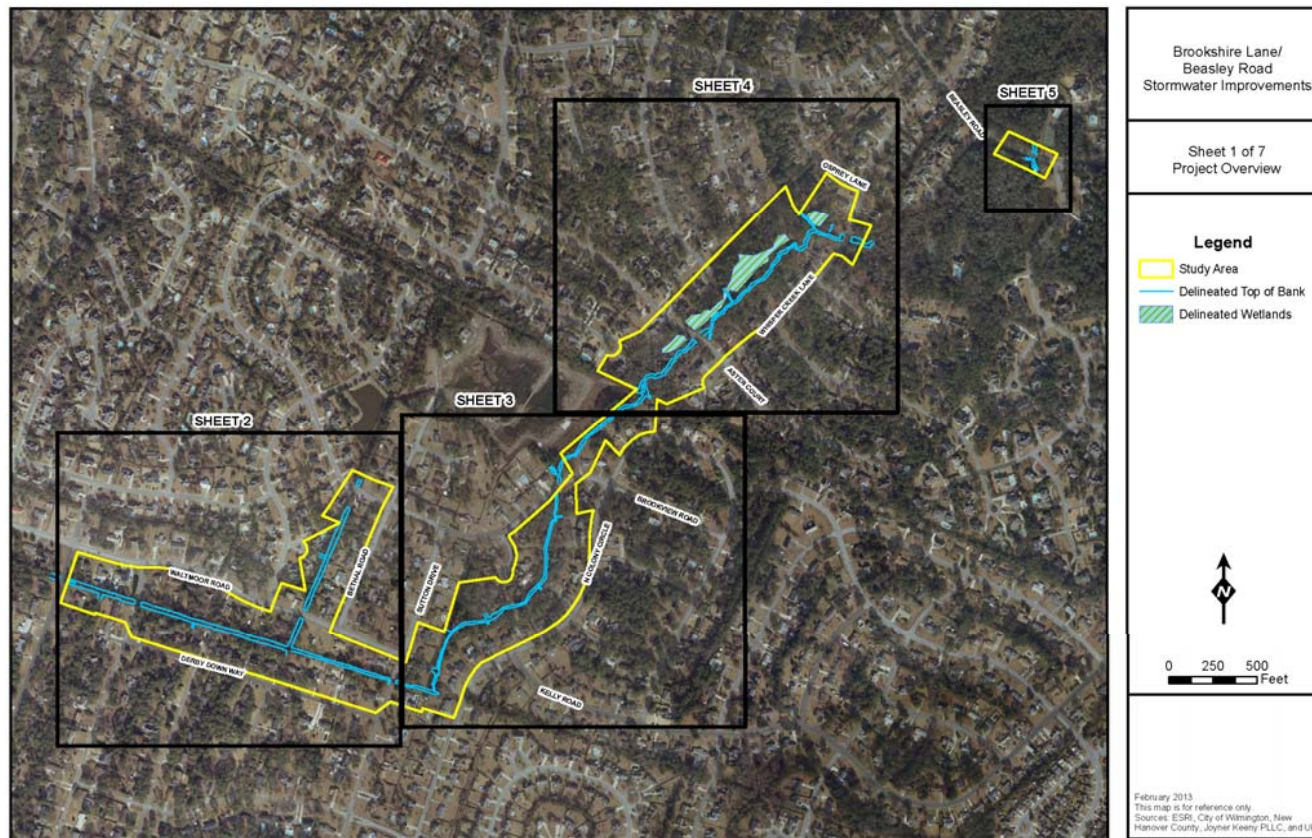
Environmental Conditions/Jurisdictional Features

- Site visits conducted on Nov 14, 2012 and Dec 4, 2012 by URS
- Met with Federal and State environmental regulators
- Regulations play a large role in design requirements for this project

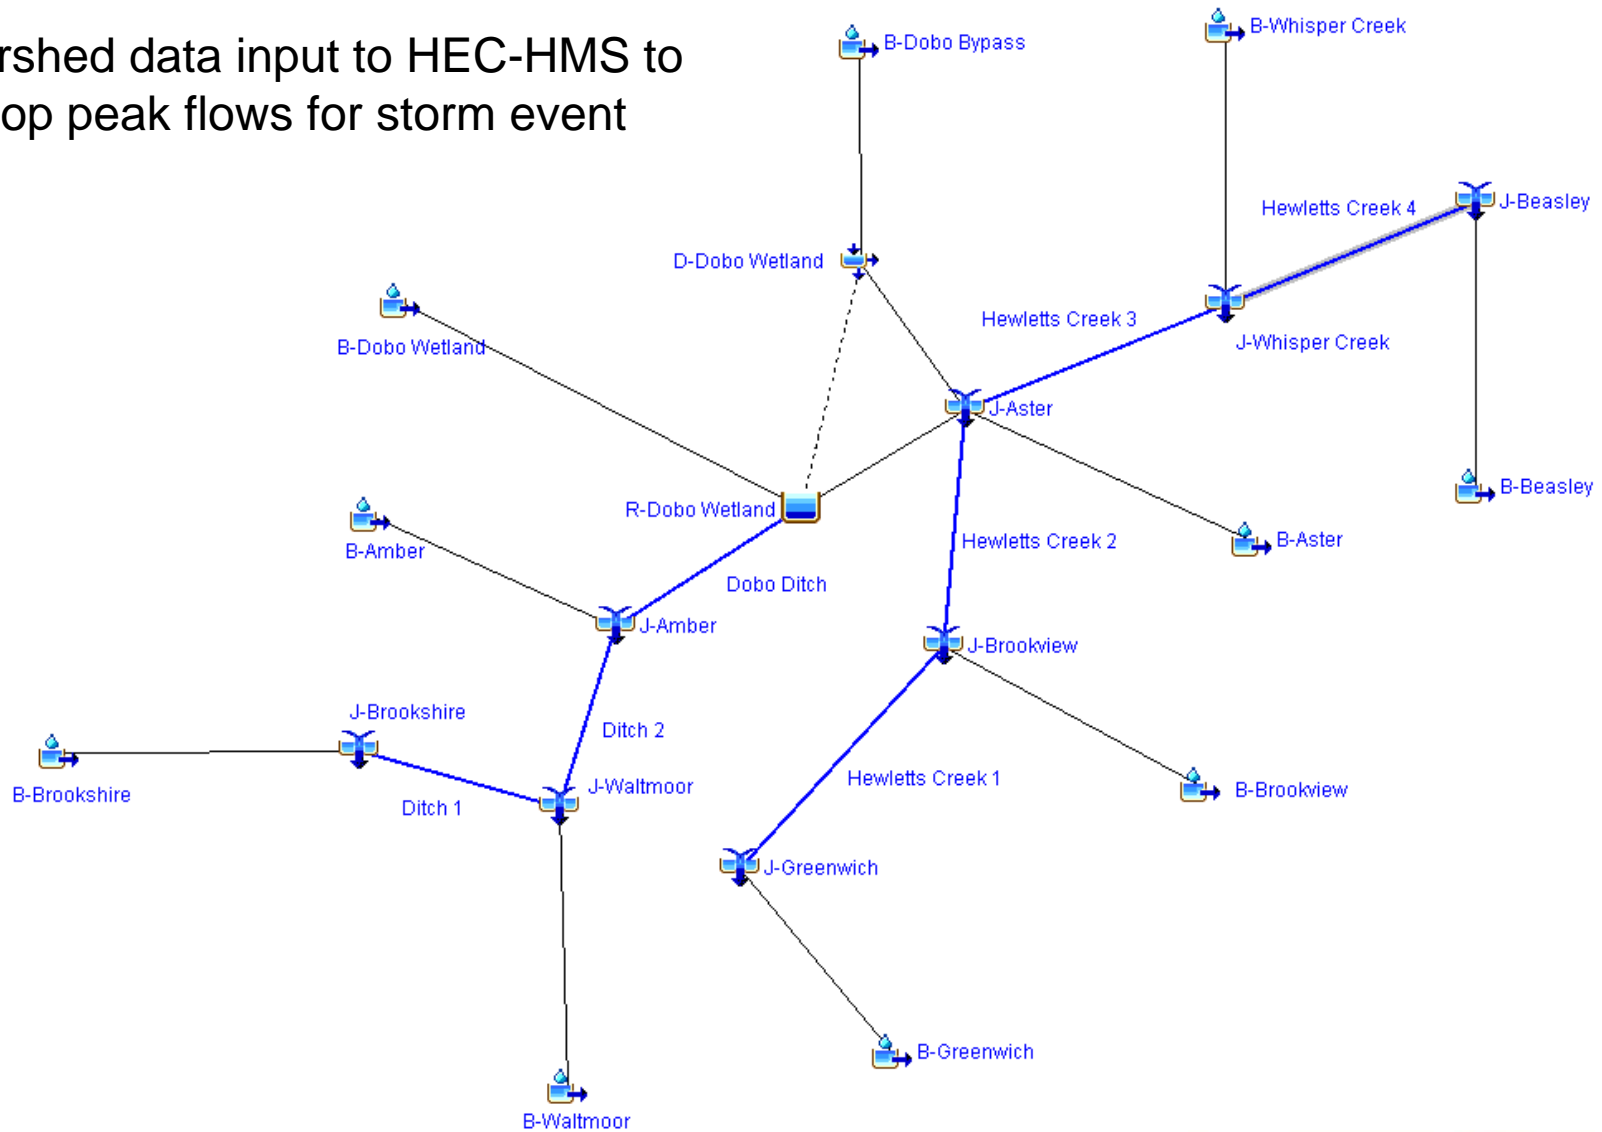
Hydrologic Modeling

Watershed data input to HEC-HMS to develop peak flows for storm event

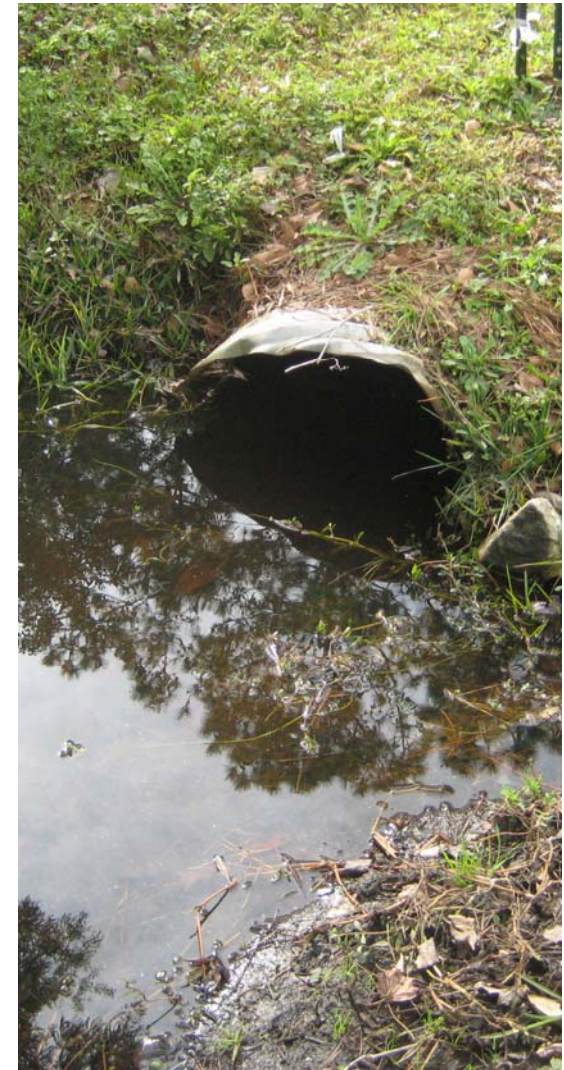
Existing Culverts

- Generally in poor condition
 - Near end of service life
 - **Undersized**
 - Standing water
 - Deteriorating pipes and headwalls
 - Full of sediment and debris
 - Poor choice of materials

Location	Road Elevation ft-MSL	Water Surface Elevation					
		2-Year		10-Year		100-Year	
	ft-MSL	ft-MSL	Flood Height (in)	ft-MSL	Flood Height (in)	ft-MSL	Flood Height (in)
Pinecliff Drive	26.26	26.67	4.9	26.95	8.3	27.47	14.5
Brookshire Lane	25.01	25.83	9.8	26.31	15.6	27.01	24.0
Waltmoor Road	24.69	25.36	8.0	25.79	13.2	26.38	20.3
Amber Drive	21.74	22.75	12.1	23.70	23.5	24.60	34.3
Greenwich Lane	22.73	22.97	2.9	23.14	4.9	23.32	7.1
Brookview Drive	19.07	19.41	4.1	19.60	6.4	20.37	15.6
Aster Court	16.23	16.67	5.3	17.02	9.5	17.56	16.0
Whisper Creek Lane	10.68	11.51	10.0	12.25	18.8	13.00	27.8

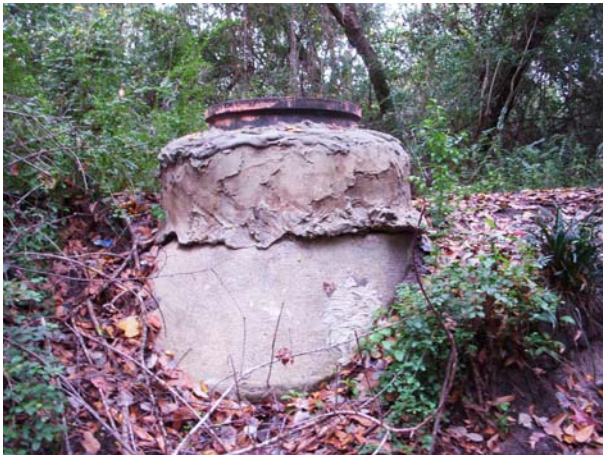
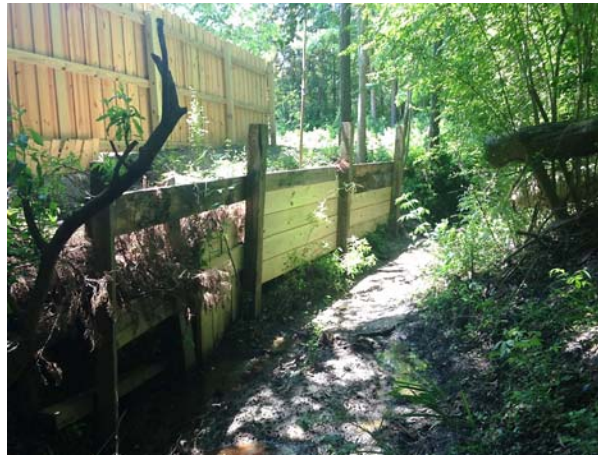
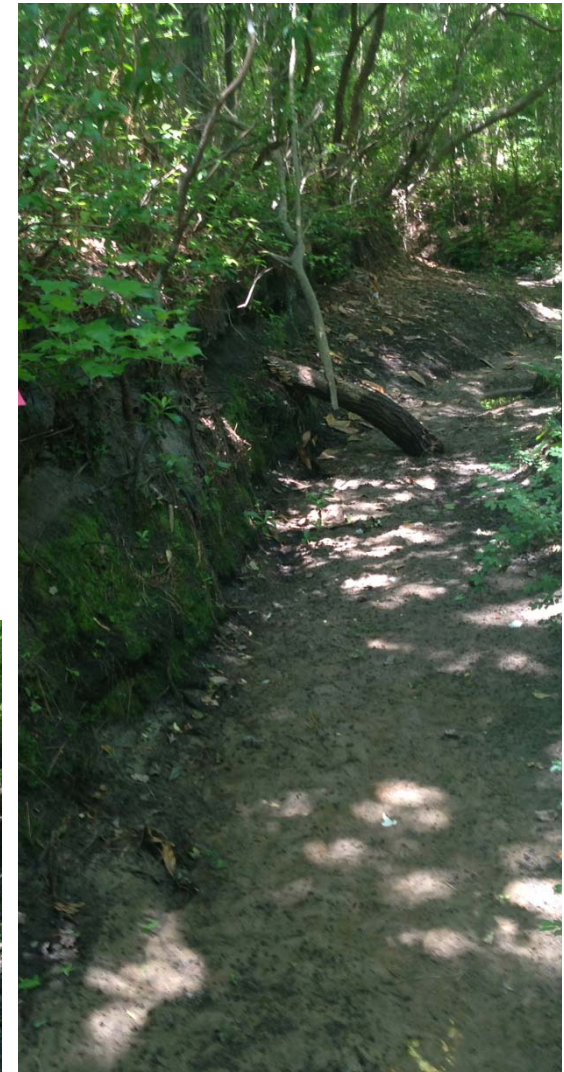
Existing Channels/Streams

- Most channels are stable and contained within a mature vegetative buffer
- Areas of bank erosion
- Channel is not contained within a drainage easement (restricted access)
- Overgrown
- Debris and trash restricting flow

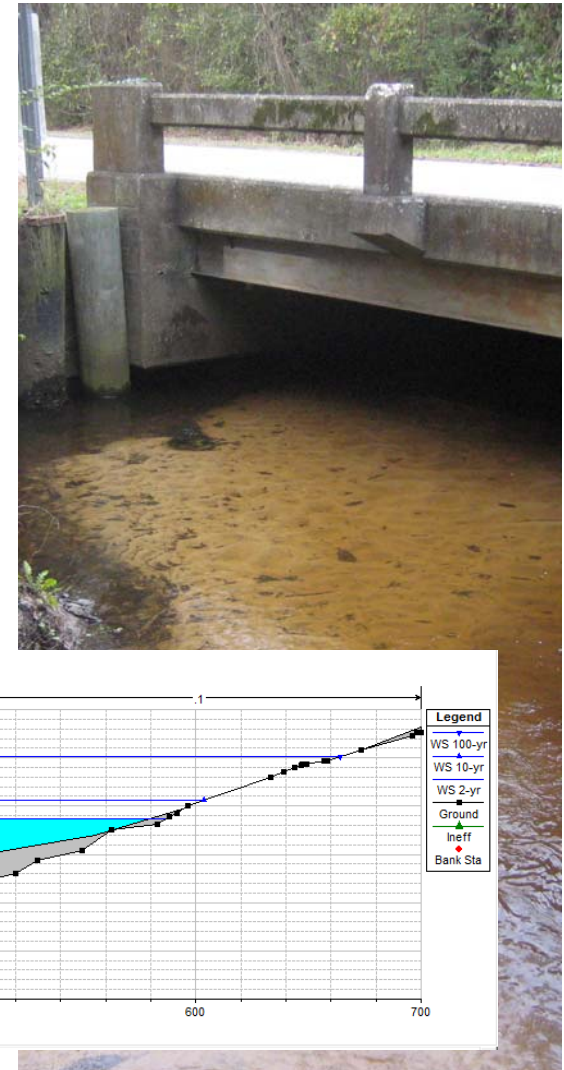
Existing Bridge at Beasley Road

- Reinforced concrete floor on I-beams
 - Near end of service life
 - **Undersized**
 - Weight limit restrictions

Location	Road Elevation ft-MSL	Water Surface Elevation					
		2-Year		10-Year		100-Year	
	ft-MSL	ft-MSL	Flood Height (in)	ft-MSL	Flood Height (in)	ft-MSL	Flood Height (in)
Beasley Road	5.84	7.47	19.6	8.19	28.2	8.99	37.8
